Check-out Report

Date: 8th May 2010

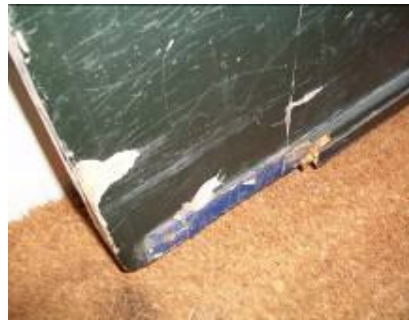
Large chip to low level on door panel

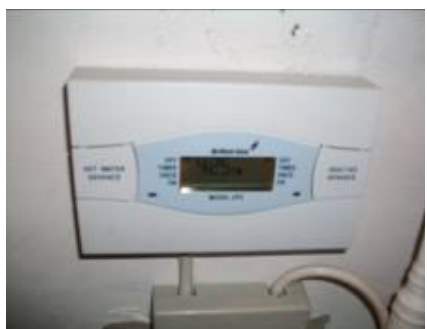
British Gas digital thermostat

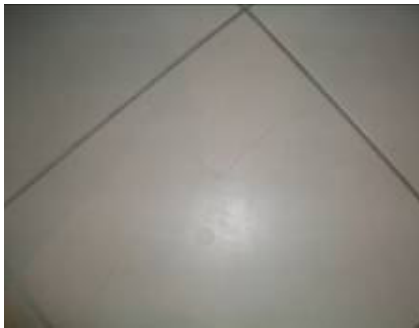
Fait hairline crack seen to floor tile

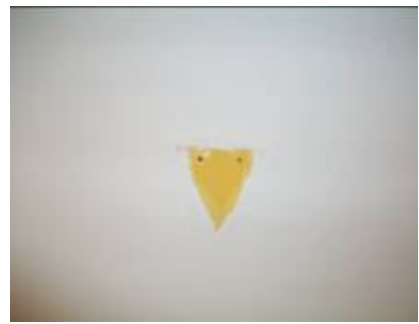
Yellow triangular defect to wall forward of entry to bedroom 2

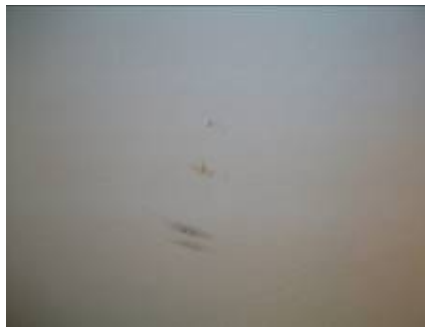
Scuffs to wall forward of bedroom 2

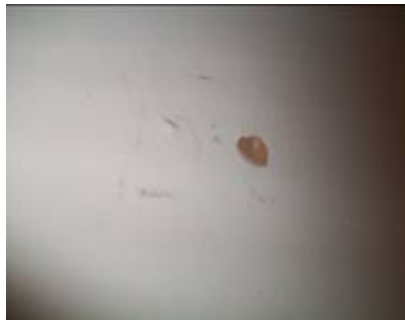
Chip and fitment holes to wall

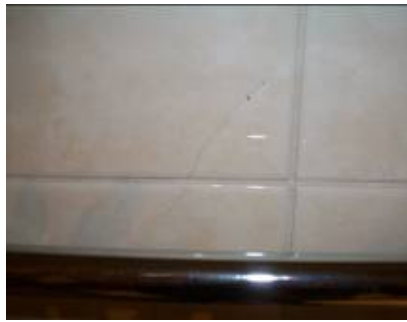
Crack to wall tile behind towel rail
